UNDERWATER BRIDGE INSPECTION REPORT

STRUCTURE NO. 40508

1ST STREET

CANNON RIVER

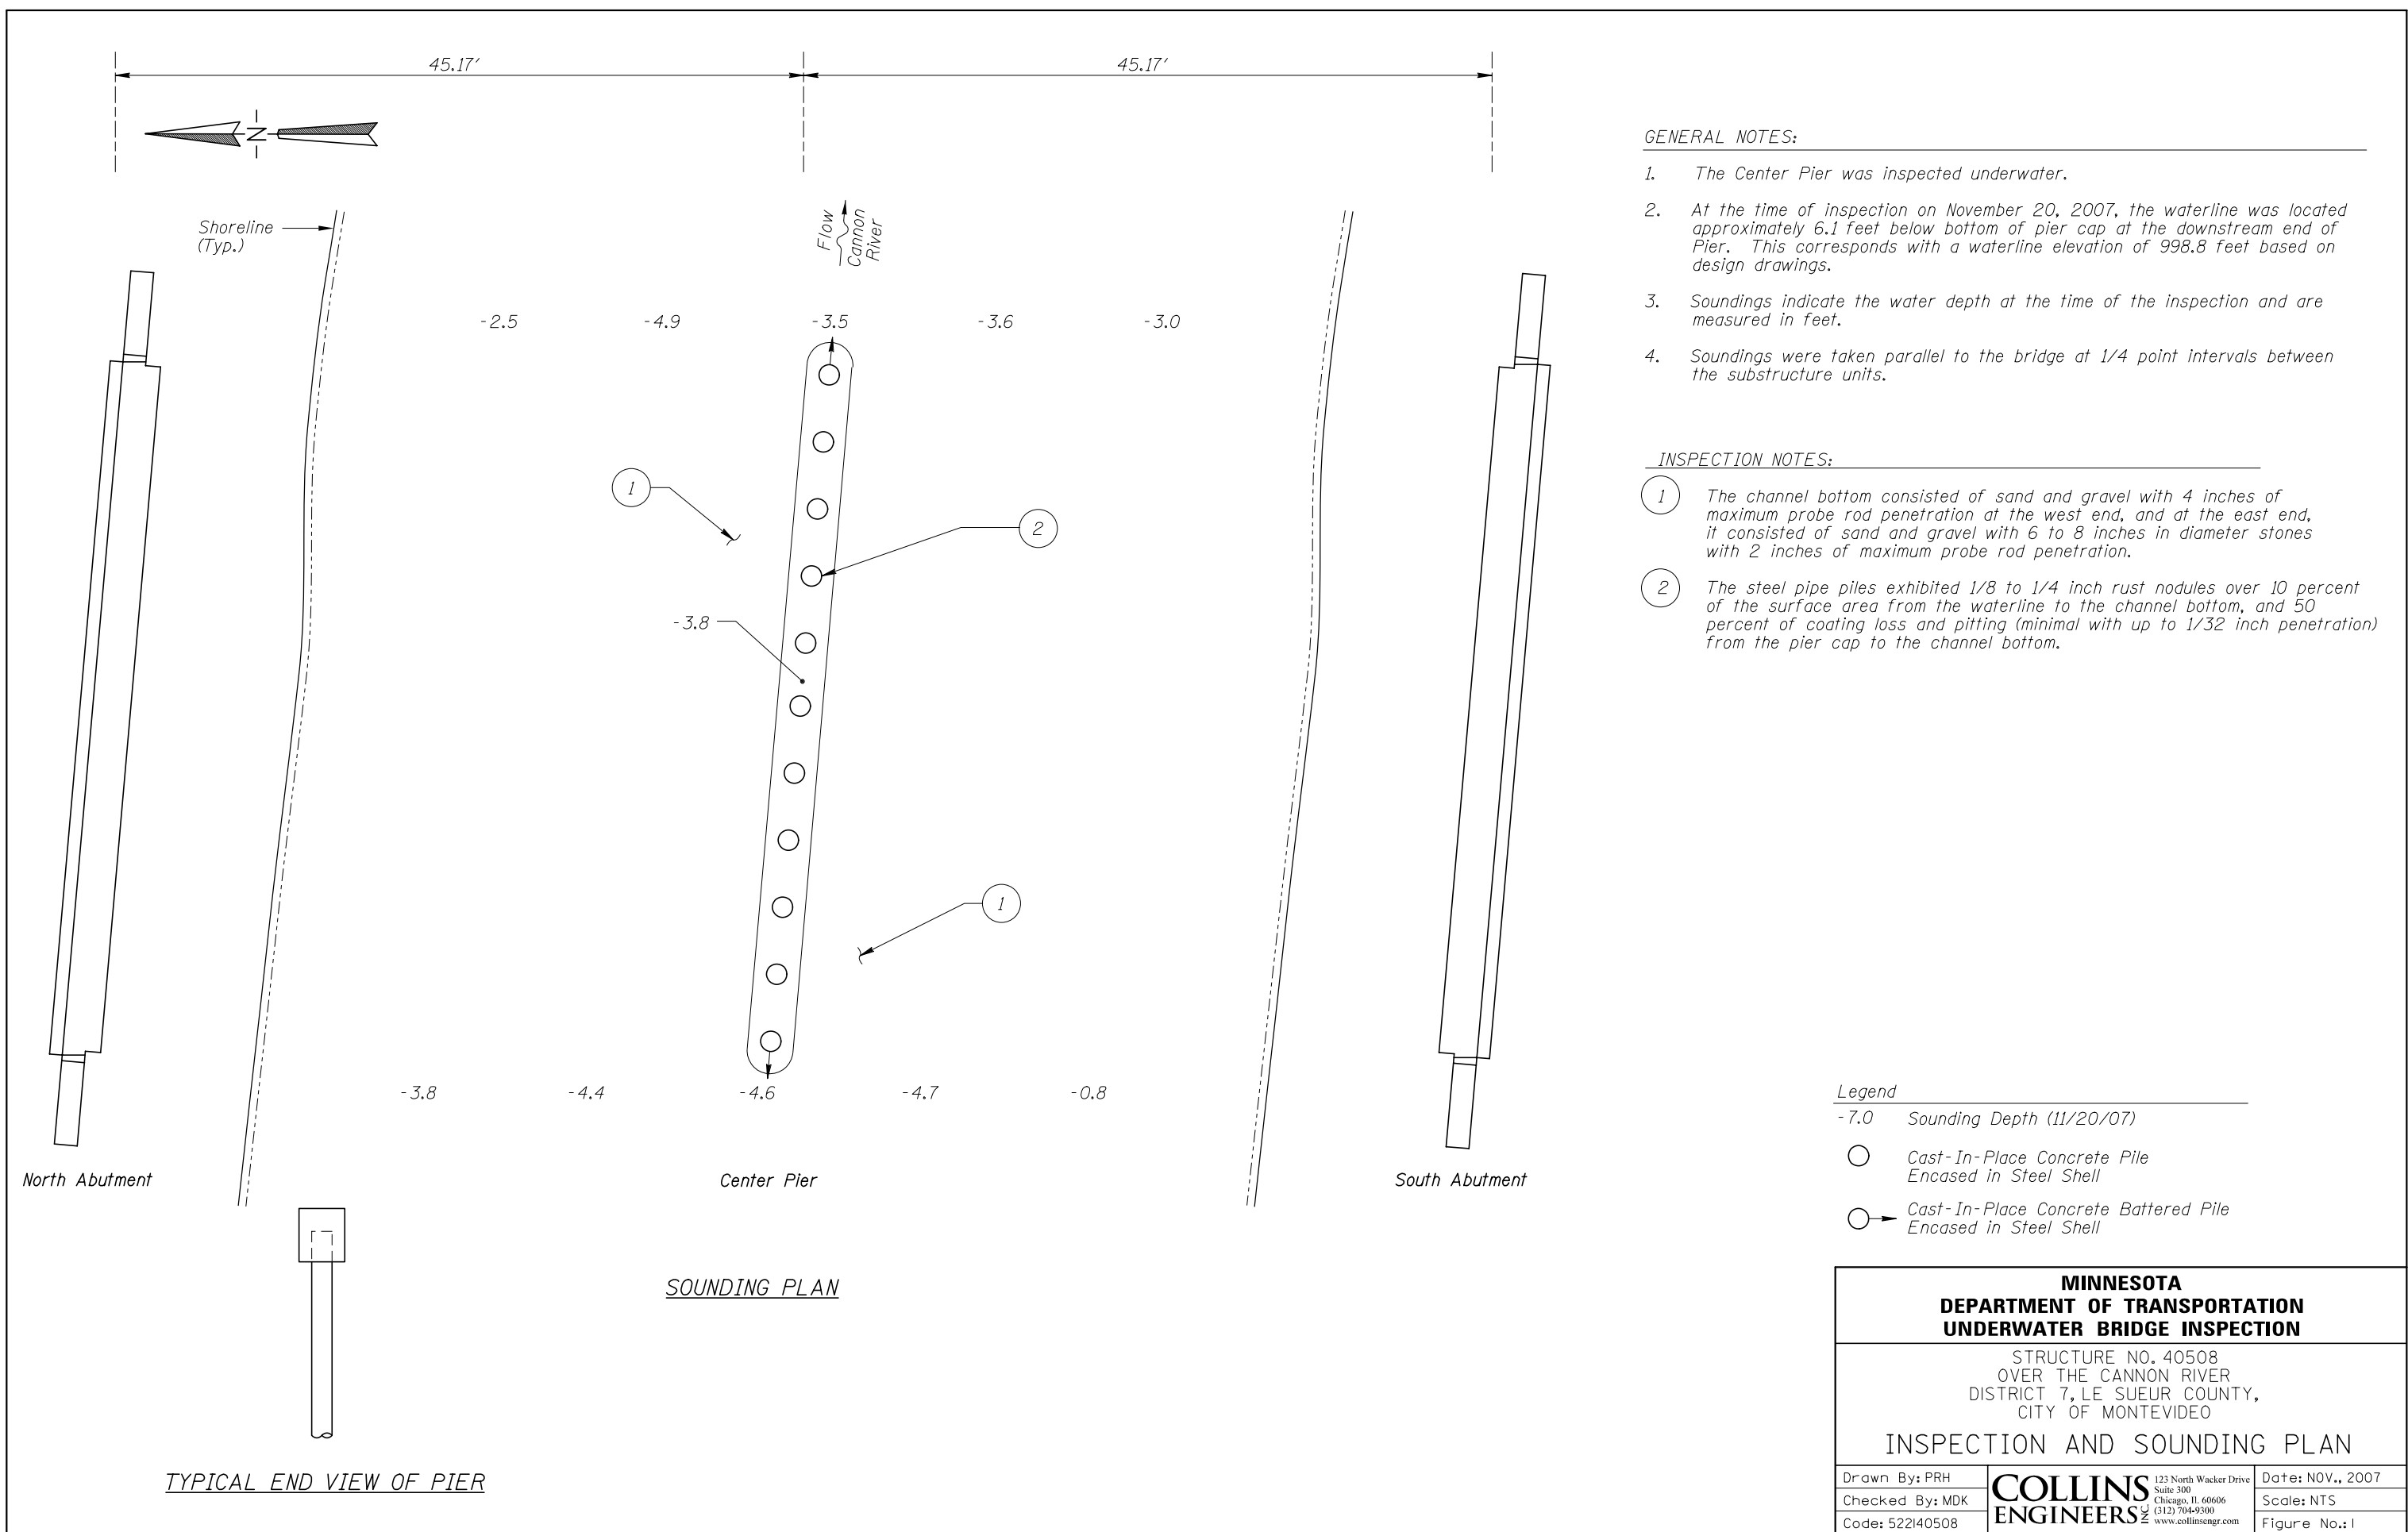
UPSTREAM FASCIA PROFILE

REMARKS: Overall, the submerged steel of the piles was in good condition with no significant deterioration. The steel piles from the waterline to the channel bottom exhibited 1/8 to 1/4 inch diameter rust nodules over 10 percent of surface area, and 50 percent of coating loss and pitting (minimal with up to 1/32 inch penetration) from bottom of the cap to channel bottom. No notable channel bottom deficiencies were encountered.

Reinspect the submerged substructure units at the normal maximum recommended (NBIS) interval of five (5) years.
